# Use case Animal feed production

## THE SITUATION:

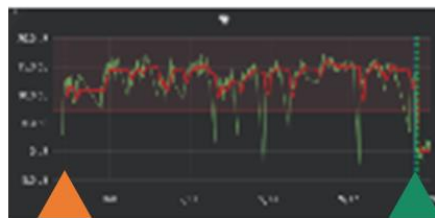
A lubrication issue (clogged filter) was detected by a significant increase in the ultrasound level :

Prevented a failure of the gearbox.

Defect detected

Filter replaced
